BERGER ASSOCIATES INC HARRISBURG PA
NATIONAL DAM INSPECTION PROGRAM. LAKE LATTIMORE DAM (NDI-ID NUM--ETC(U)
JUN 80 DACW31-80-C-0019
NL

**PHASE I INSPECTION REPORT
NATIONAL DAM INSPECTION PROGRAM**

BERGER ASSOCIATES, INC.
HARRISBURG, PENNSYLVANIA

DATE: June 19, 1980

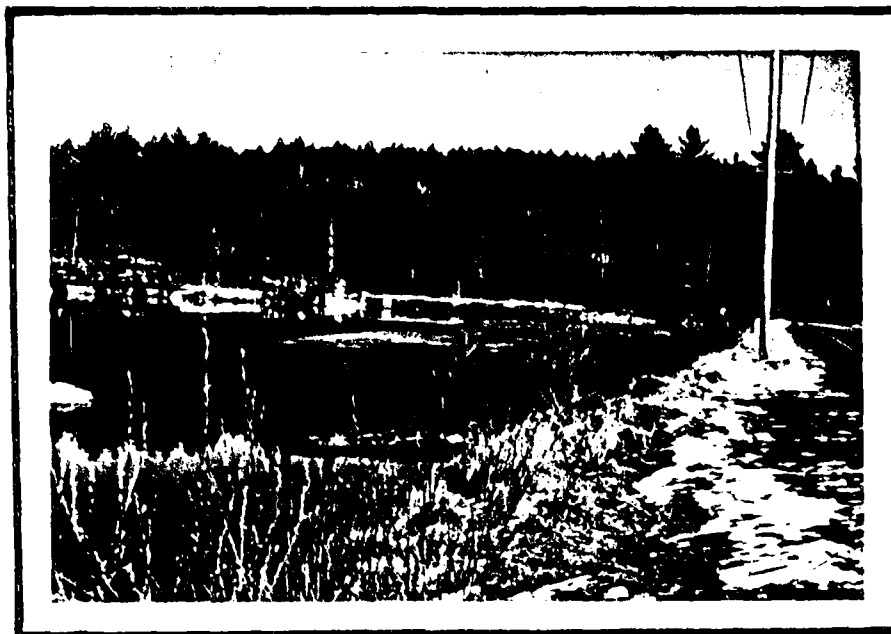
VIEW FROM HIGHWAY TO UPSTREAM SLOPE - NO. 2

The general appearance of Lake Lattimore is fair. Brush and trees are growing on the upstream and downstream slopes of the embankment. The spillway ogee section has some spalling of concrete and the gates on the outlet facilities are rusted and could not be operated during the inspection.

2. That all brush and trees be removed from the embankment slopes and that a professional engineer, experienced in the design and construction of dams, be consulted for the removal of tree stumps and roots.
3. That the drawdown facilities be made operable and be operated and maintained on a regular basis.
4. That the deteriorated areas of the spillway weir and walls be repaired.
5. That a formal surveillance and downstream warning system be developed for use during periods of high or prolonged precipitation.
6. That an operation and maintenance manual be prepared for guidance in the operation of the dam during normal and emergency conditions, and that a schedule be developed for the annual inspection of the dam and its appurtenant structures.

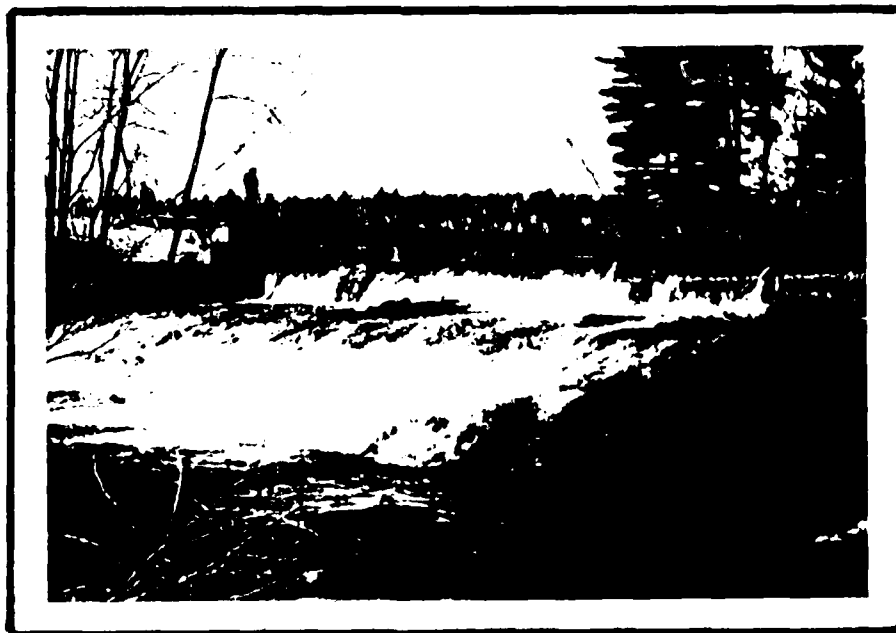
LOOKING UPSTREAM TO SPILLWAY - NO. 7

C. DISCHARGE CHANNEL: Lining Cracks Stilling Basin	Discharge channel below ogee is stone lined and has a slope break in the flow path. Several large (4" to 6") clump trees are growing in the channel just at the toe of the chute. There is no stilling basin.
